**Addendum to:**  
**Resource Replacement Alternatives Involving**  
**Constructed Reefs in Southern California**

**Evaluation of Artificial Reefs as Restoration Options  
for Injuries Resulting from DDT in Fish Tissue that  
Exceeds FDA Action Levels and California State  
Trigger Levels**

Richard F. Ambrose, Ph.D.

April 14, 2000

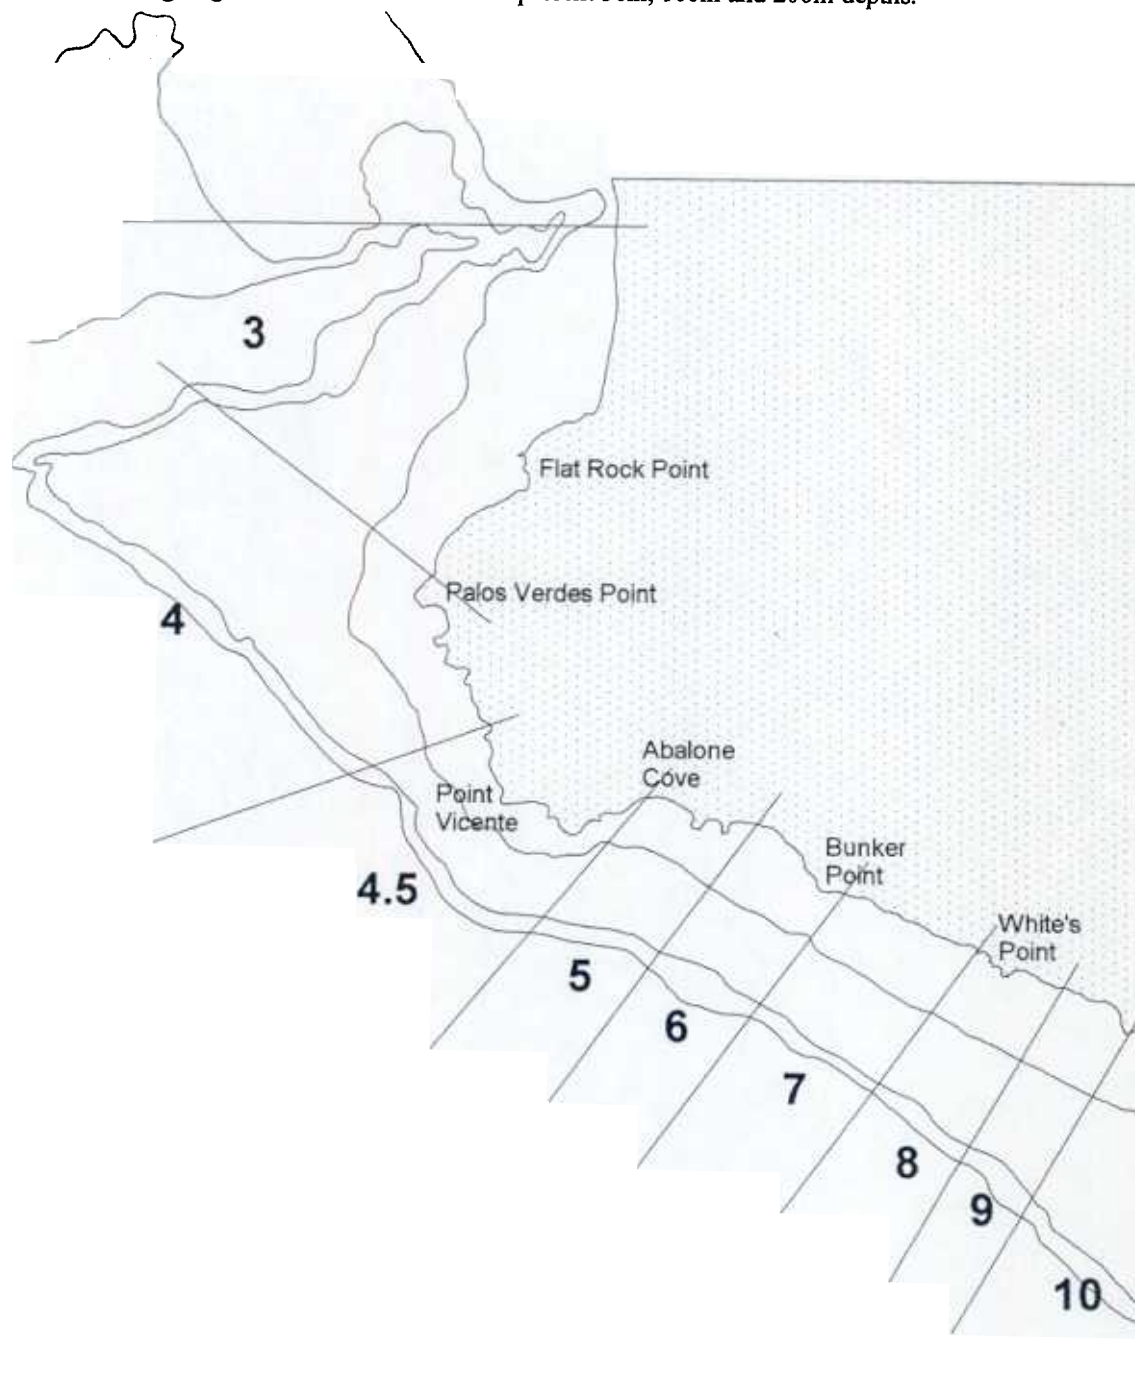
Figure 1. Shoreline segments used for standing stock and contaminant analyses in the Palos Verdes region. Contour lines going from inshore to offshore represent 30m, 100m and 200m depths.

Exceedances were estimated for different segments of the Palos Verdes Peninsula. HydroQual (1997) previously described the coastal segments I use in this report, with two modifications. HydroQual's originally identified eight segments covering the Palos Verdes Peninsula, numbered 3 through 10. QEA added a new segment, 4.5 (called 4A in QEA's report, Appendix 2), mostly within the original segment 4, and shifted the boundary between 4.5 and 5 slightly eastward. Approximate coordinates for shoreline boundaries and compass headings for the coastal segments are given in Figure 1. Note that HydroQual's segments 3 and 10 are larger than shown in the figure; I truncated them for my analysis because they extend beyond the Palos Verdes Peninsula region. The regions of segments 3 and 10 that are not included in this analysis are sufficiently different from the PV Shelf area that biomass estimates from the LACSD trawls should not be extrapolated to them. No estimates were made for segment 10 because there were no exceedance estimates for the portion of 10 that would be included in my analysis.
